**SOME CREEP CHARACTERISTICS OF
BERYLLIUM-COPPER AT 300°C**

James G. Curry

MASTER OF SCIENCE
IN
MECHANICAL ENGINEERING

from the
United States Naval Postgraduate School

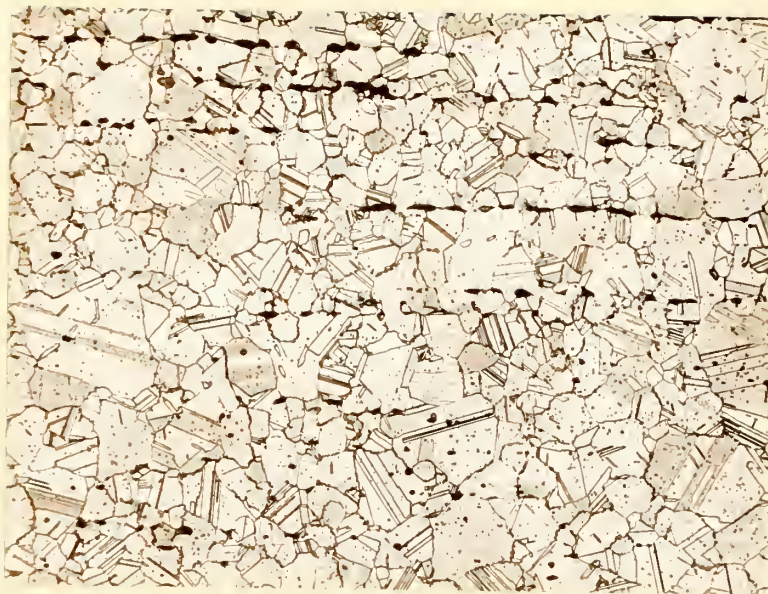
FIGURE 1--A Condition

The appearance of the microstructures of these states before testing are shown in Figures 1 - 5, respectively. These micrographs show the presence of beta stringers which are due to incomplete homogenization. These beta stringers may have several undesirable characteristics; one of these is that the amount of beryllium in the alpha phase is reduced and is therefore not "available" for hardening. In addition, the "as-received" material (see Figures 1 and 3) showed a condition variously described as "grain boundary precipitate" or "grain boundary gamma". The cause or composition of this boundary phase is not fully understood and is the subject of considerable controversy⁽⁶⁾. However, this formation results, at least in part, from commercial mill practice. Its effect is to form clumps or masses of a phase along the grain boundaries that may have many undesirable consequences, among them excess distortion of the piece when heat treated. A slight amount of visible general precipitate within the grains and beryllites (beryllium-cobalt intermetallic compounds) were observed in the unaged material.

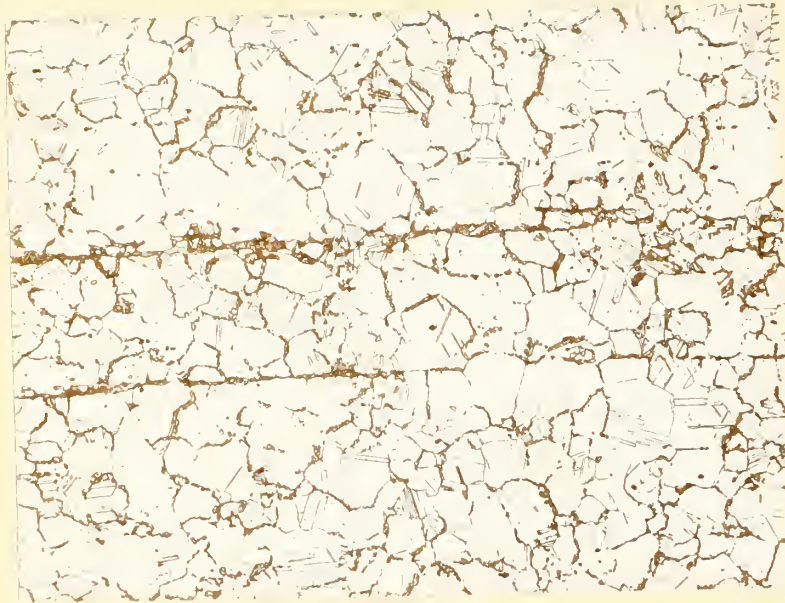
FIGURE 2--AT-316 Condition

grain boundary precipitate mentioned earlier. In the case of the cold-worked material negligible or no distortion was in evidence. The microstructures obtained by this treatment are shown in Figures 2 and 4.

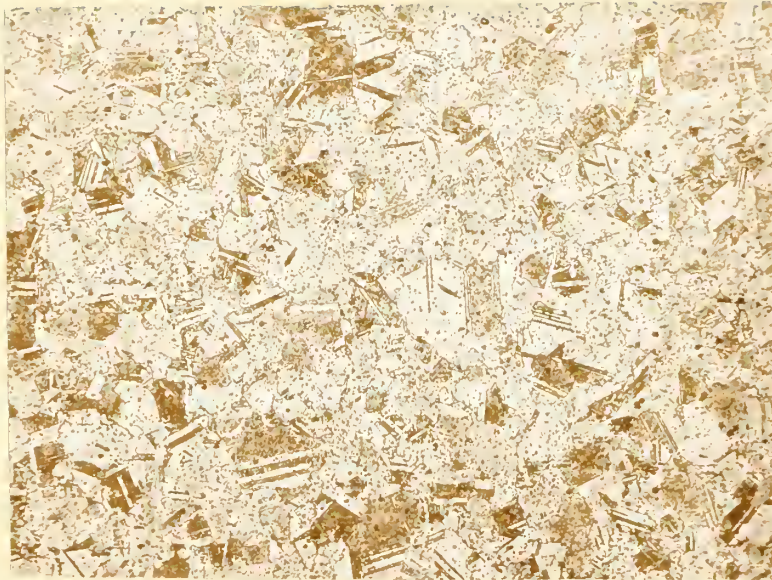
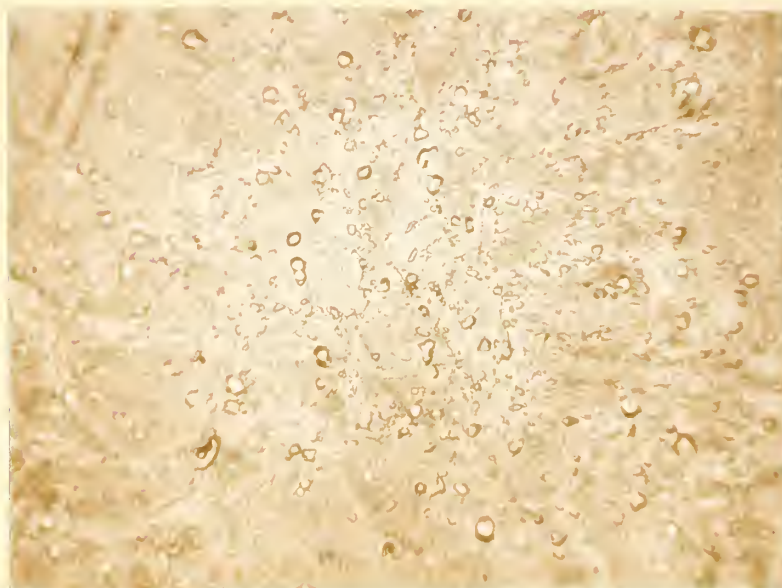
FIGURE 5--AT-600 Condition

The high-temperature over-aging treatment, which produces the lowest static strength and most ductile condition, was accomplished in a vertical tube furnace utilizing a helium atmosphere in order to prevent oxidation during the 70 hour treatment at 600°C. (1112°F.). Upon completion of this heat treatment, the temperature was lowered at approximately 10°C./hr. The resulting material (see Figure 5) was much less subject to structural change on further reheating than it was in the solution-treated or fully aged state in either the stressed or unstressed condition, precipitation of the second phase being much more complete.

coalescence and spheroidization of the second phase as shown in Figure 5b. Geisler⁽¹¹⁾ points out that many of these precipitation reactions may be occurring in the alloy at different areas simultaneously, or they may start after widely different incubation periods.

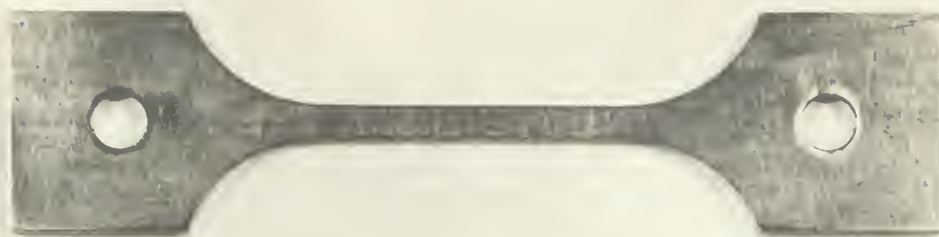
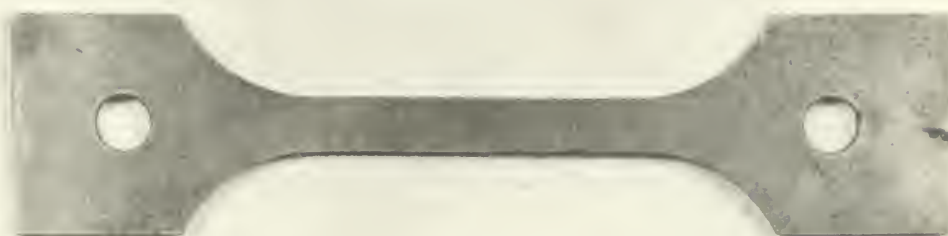
Figure 8 - Test Specimens

At the beginning of this investigation it was assumed that the customary creep specimen design (see Figure 8c), being employed in the Creep Testing Laboratory of the U. S. Naval Postgraduate School, would be adequate. Upon completion of the first test on a specimen, in the HT-316 condition, based on this design it appeared that this assumption was justified as the fracture occurred within the gage section. However, the next four fractures occurred at the grip section as shown in Figure 9c). These tests were conducted on specimens in the H and HT-316 conditions.

This, obviously, meant that a design change was in order. A 60% increase in the width of the grip section was considered sufficient; this modification constituted the intermediate design as shown in Figure 8b. Four tests were then conducted using specimens of such design, in the A, H and HT-316 conditions. All of these tests resulted in fractures in the same location (see Figure 9b) as in the previous four tests.

- (a) Final Design
- (b) Intermediate Design
- (c) Initial Design

Design	Grip Width, in.	Reduced Section Width, in.
Initial	5/8	1/4
Intermediate	1.0	1/4
Final	1.0	5/32

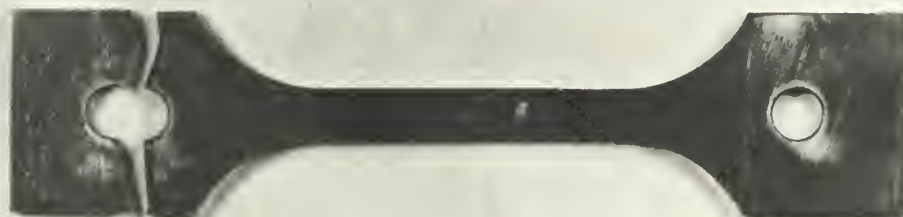
Figure 9 - Test Specimens Showing Location of Fractures Under Creep Tests at 3000C.

- (a) Final Design, AT-316 Condition
- (b) Intermediate Design, HT-316 Condition
- (c) Initial Design, AT-316 Condition

While this final change did cause the location of the fractures to shift to the reduced section (see Figure 9a), it did not solve the problem entirely. A summary of the location of fractures utilizing this design is shown in Table IV.

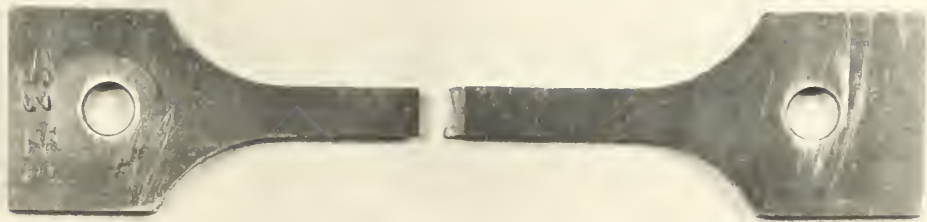
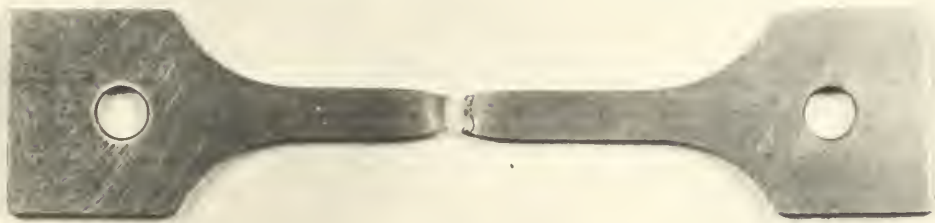
Figure 10 - Test Specimens Showing Location of Fractures
Under Short-Time Tensile Tests at Room Temperature

At this stage of the investigation, the writer's thoughts were, "Would these designs prove adequate when subjected to short-time tensile tests at room temperature?". The results of such tests are shown in Figure 10. Of course, the next logical

- (a) Intermediate Design, HT-316 Condition
- (b) Intermediate Design, H Condition
- (c) Initial Design, H Condition
